LAB TEST REPORT
Validation CAV Flow Rates

Client:	
Project no:	2016003
Project name:	CAV
Date:	21/08/2016

Test description:	validate claimed flow rates as mentioned on CAV
Product tested:	3 Turkish brands (types unknown)

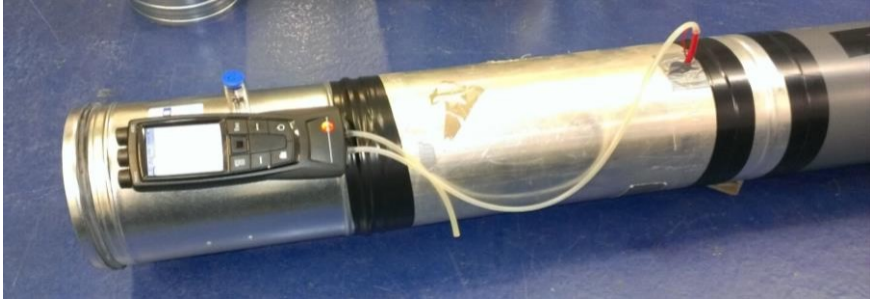
TEST CONDITIONS

The CAV was connected to the calibrated orifice ACIN 33984. Pressure losses were measured 0,5 m upward of the CAV. Note that NO duct was mounted after the CAV: this resulted in a higher pressure loss of 20-40 Pa. Several flow rates from the working range were imposed at the prescribed pressure loss of 250 Pa. Note that the latter pressure loss could not be reached for the higher flow rates, i.e. close to the maximum values (although the fan is capable to it). The cause is unclear as the valve was not in its extreme position; it was like the spring was already at maximal tension!?).

When testing CAV 3 we used a different measuring set. We connected the CAV to our VAV200-1 (Was calibrated with the orifice ACIN 33984). And we mounted a duct before(1,5m) and after the CAV (0,5m). Several flow rates from the working range were imposed at the pressure loss of 250 Pa and 150 Pa.
